# UNDERWATER BRIDGE INSPECTION REPORT

STRUCTURE NO. 27554

CROW RIVER

MINNESOTA DEPARTMENT OF TRANSPORTATION  
UNDERWATER BRIDGE INSPECTION

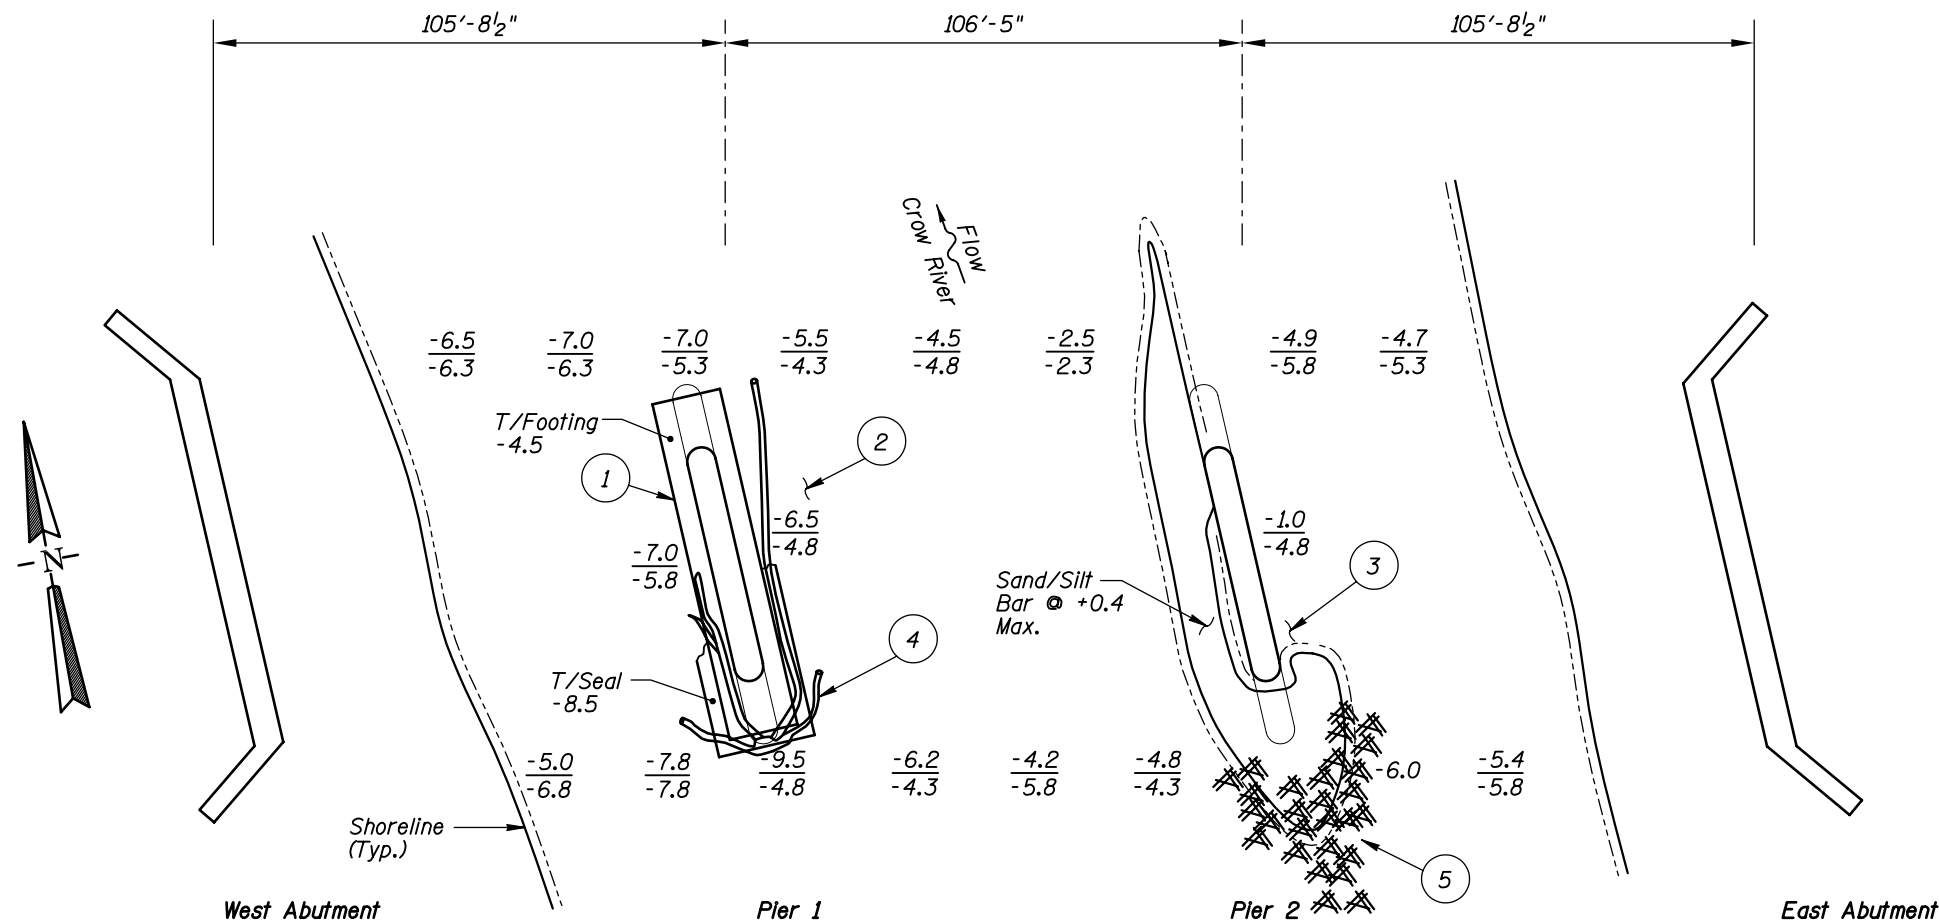
**INSPECTION AND SOUNDING PLAN**

1. The top of footing was completely exposed around Pier 1 with 2 to 2.5 feet of vertical exposure along the west face and downstream end. The seal coat below the footing (full height of 4 feet of footing exposed) was exposed at the upstream end, to the 1/4 point on the west face, and to the midpoint of the east face with a maximum vertical face exposure of 2 feet at the upstream nose.
2. The channel bottom consisted of sand at Pier 1.
3. The channel bottom consisted of silt with up to 2 feet of probe rod penetration.
4. A tree trunk was observed at the upstream end of Pier 1 with 10-inch-diameter branches extending along both faces of the pier.
5. A heavy accumulation of timber debris was observed at the upstream end of Pier 2 on the sandbar surrounding part of the pier.

- (A) Remove the timber drift that has accumulated around the piers including the tree on the channel bottom at Pier 1, which could be contributing to scour and footing exposure.
- (B) Monitor footing exposure at Pier 1 during future underwater inspections.

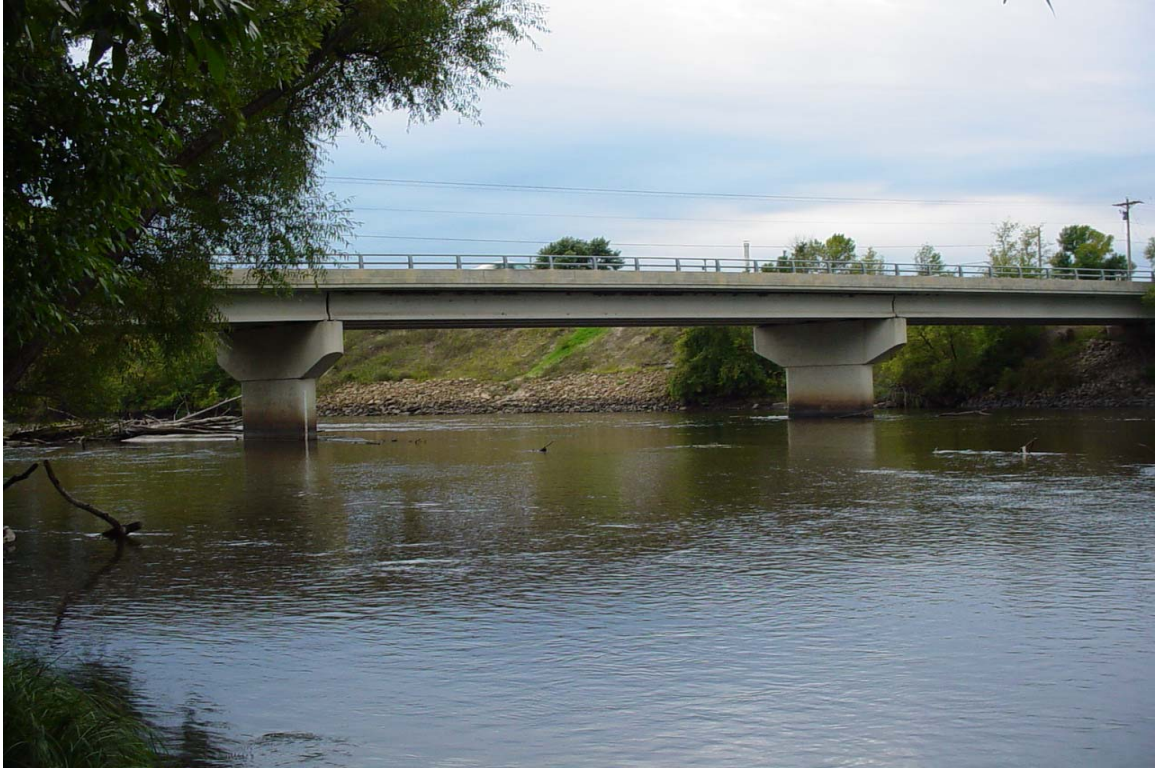
Photograph 1. Overall View of the Structure, Looking South.

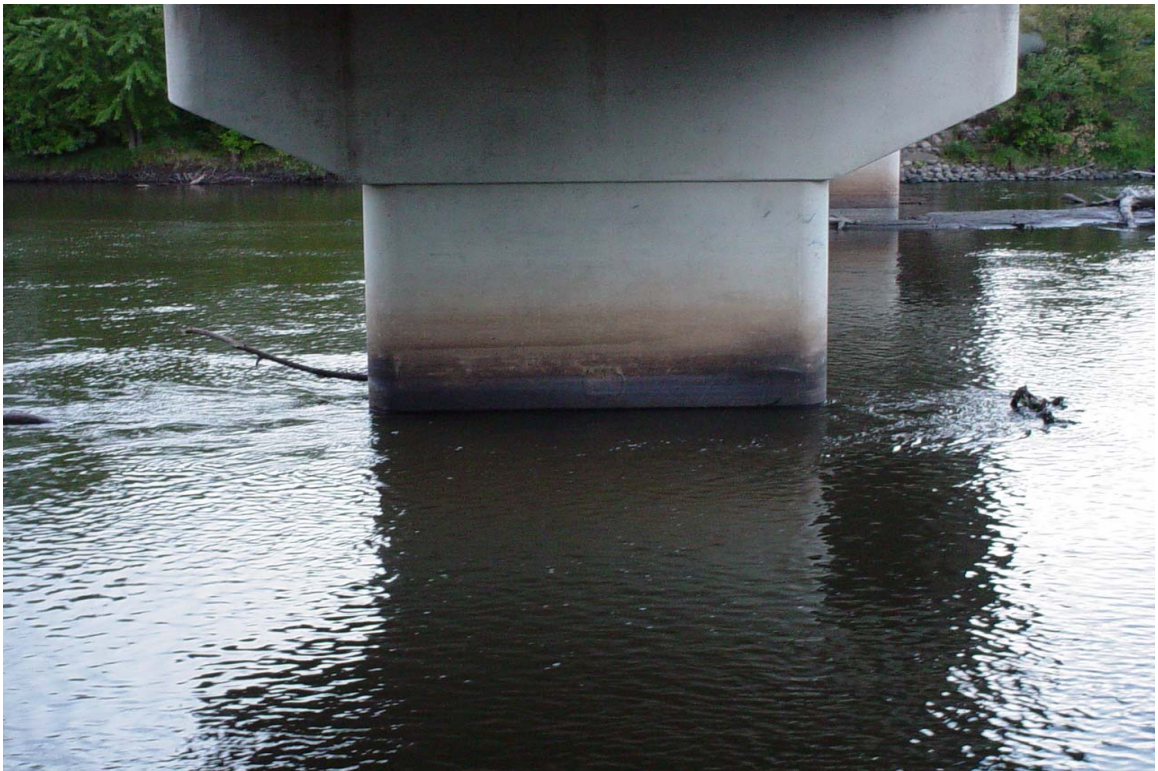
- (A) The top of footing was completely exposed around Pier 1 with 2 to 2.5 feet of vertical exposure along the west face and downstream end. The seal coat under the footing was exposed at the upstream end (full 4 foot height of footing exposed), to the 1/4 point on the west face and to the midpoint of the east face, with a maximum vertical face exposure of 2 feet at the upstream nose.
- (B) A tree trunk was observed at the upstream end of Pier 1 with 10-inch-diameter branches extending along both faces of the pier. A heavy accumulation of timber debris was also observed upstream of Pier 2 on a sandbar that surrounded part of the pier.

Photograph 2. View of Pier 1, Looking East.

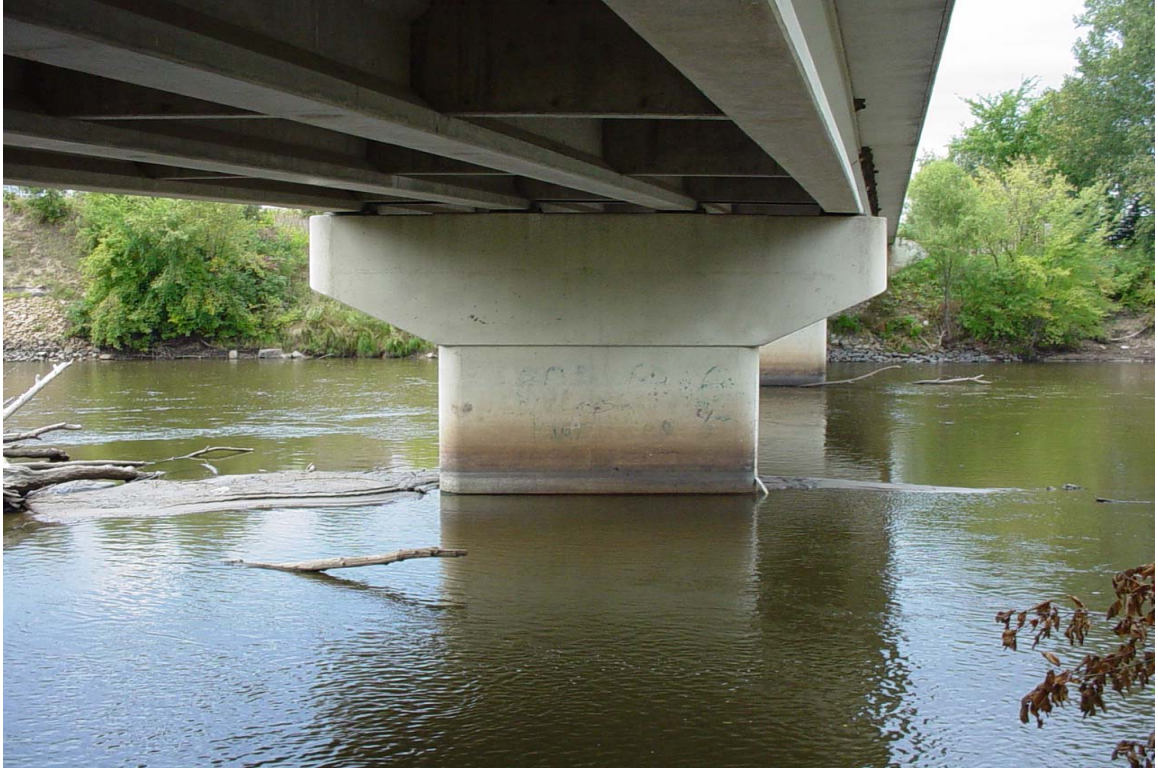
Photograph 3. View of Pier 2, Looking West.

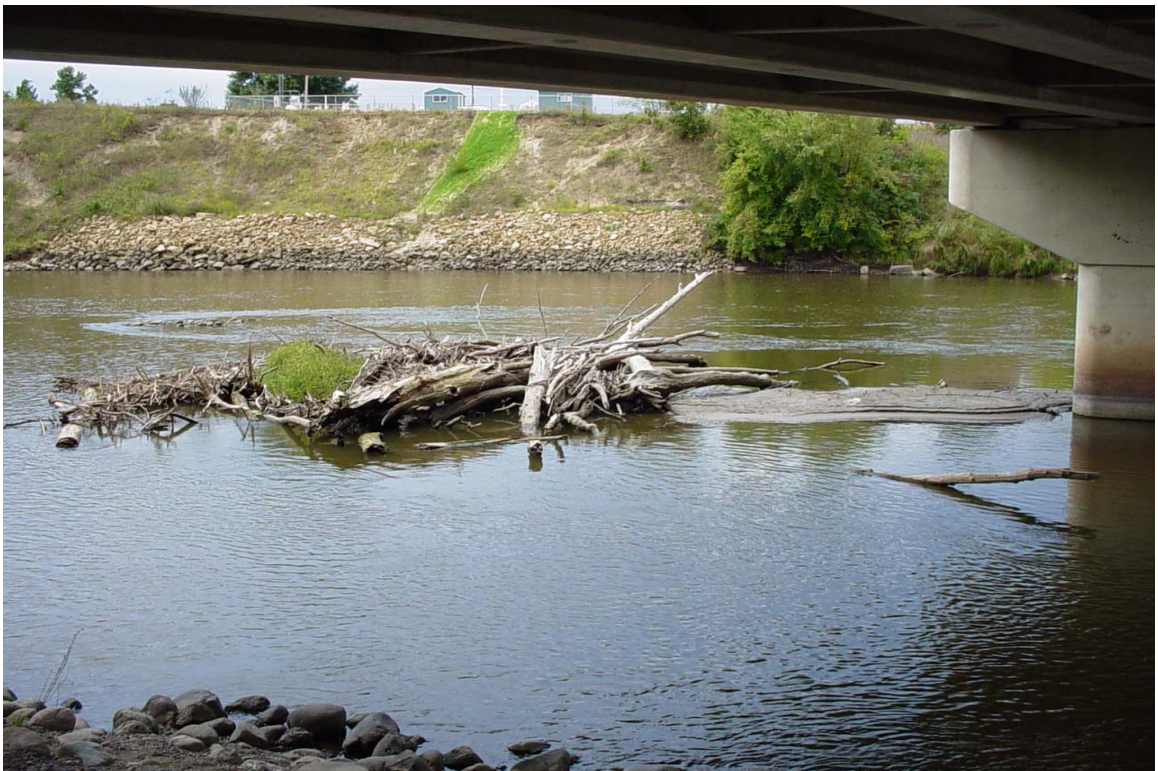
Photograph 4. View of Timber Debris at Pier 2, Looking West.
